REPORT OF THE COURT OF INQUIRY,

REPORT OF MR. ROTHERY,

**Circumstances attending the Fall of a Portion of the Tay Bridge
on the 28th December 1879.**

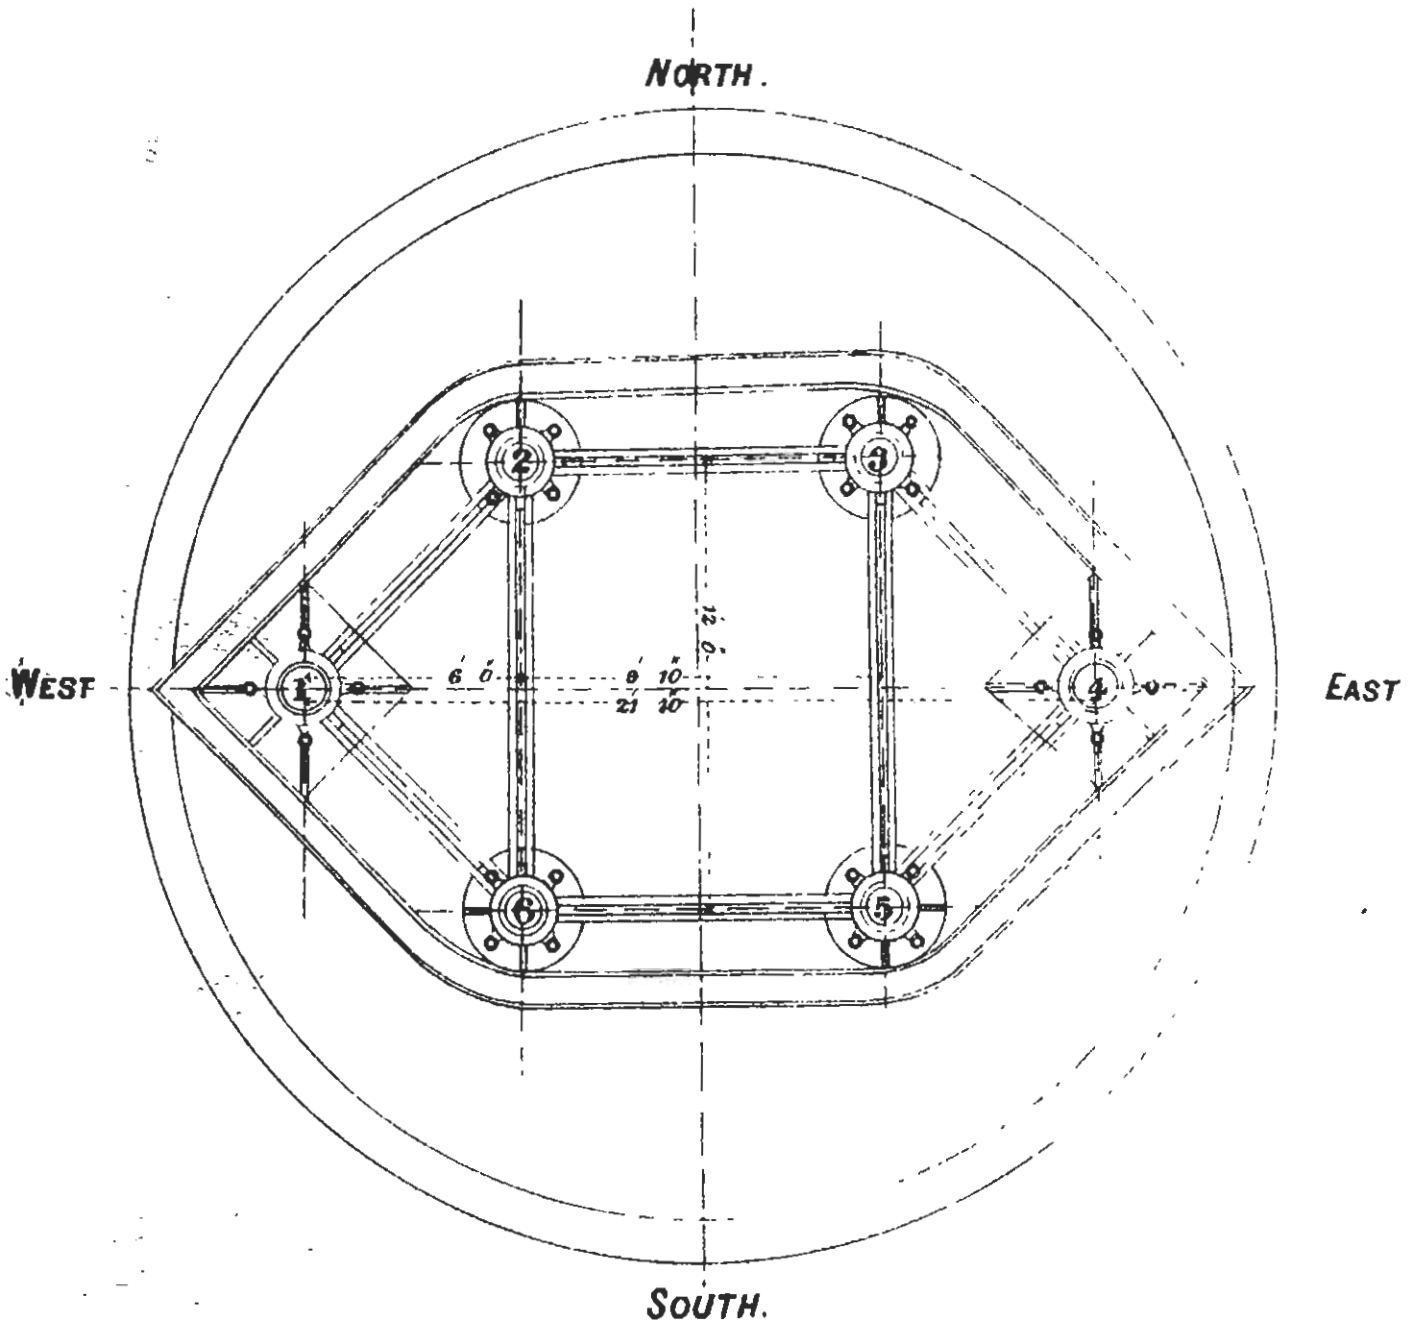
SECTIONAL PLAN OF THE BASE OF ONE OF THE FALLEN PIERS ..

The piers which supported the high girders were of peculiar construction, the nature of which is fully described in Mr. Law's report; and as they were evidently the first portion of the structure that yielded from some cause, it becomes necessary to refer to them more in detail. The foundations were formed by constructing wrought-iron caissons 31 feet in diameter, which, having been lined with 18 inches of brick-work, were floated out and sunk in their proper places. This was an extremely difficult operation, but appears in every instance to have been successfully performed. After sinking the caissons as low as was deemed necessary, the centre was filled up with concrete, and upon this was built an hexagonal-shaped pier, measuring 27 feet 6 inches long, and 15 feet 6 inches broad. The lower part of this pier was made of concrete faced with brick, and was surmounted by four courses of stone backed by concrete. On this pier was placed, at the angles of the hexagon, six cast-iron base pieces, 2 feet in height, and secured to the pier by holding-down bolts, $1\frac{1}{2}$ inches in diameter, passing through two courses of stone, each 15 inches in thickness.
