Forensic engineering: a reappraisal of the Tay Bridge disaster

PETER R. LEWIS and KEN REYNOLDS

Department of Materials Engineering, Open University, Milton Keynes, UK

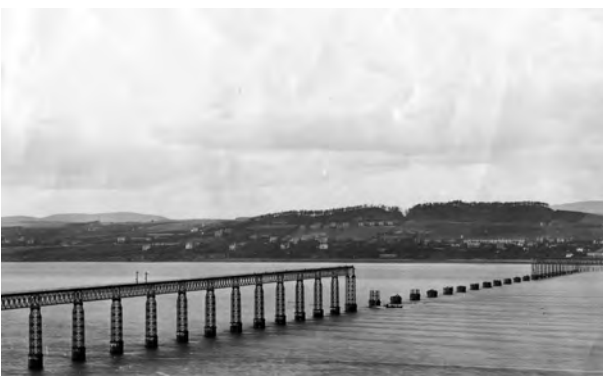
3 Long shot of the collapsed high girders section of the bridge, with twelve pier platforms almost completely swept off their high towers

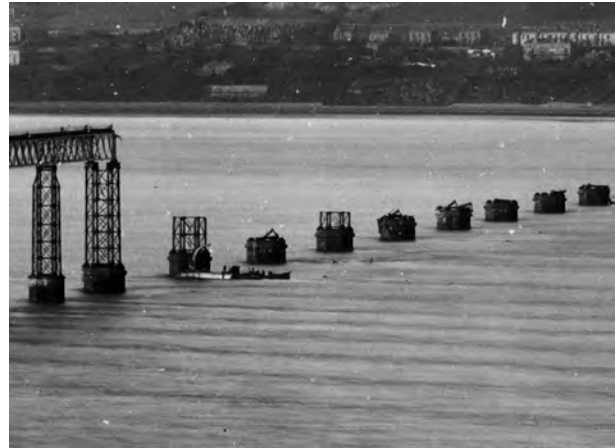
4 Closeup of the join between the low and high sections of the bridge showing partly intact tiers on two piers. The boat in the foreground is searching for survivors in the girders, which are just visible in front of the third fallen pier, poking above the waterline. Numerous tie bar breaks can be seen in the centre of the last standing tower

standing towers of the low sections, although some of the west facing bars were also fractured at their lug attachments (Fig. 4).

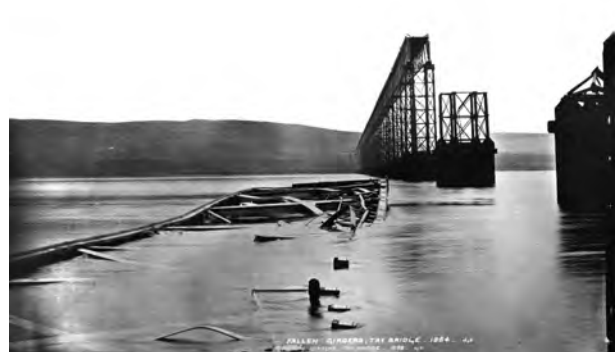
day, they found no survivors or bodies. The high girders were resting on the estuary bed, in a remarkably intact state and partly exposed at low tide (Fig. 5). Divers later found the train resting between the fourth and fifth piers, relatively little damaged

5 Side of the high girders seen at low tide. The girders were found almost intact close to the pier bases, and laid out in a wave form alongside the high section of the bridge

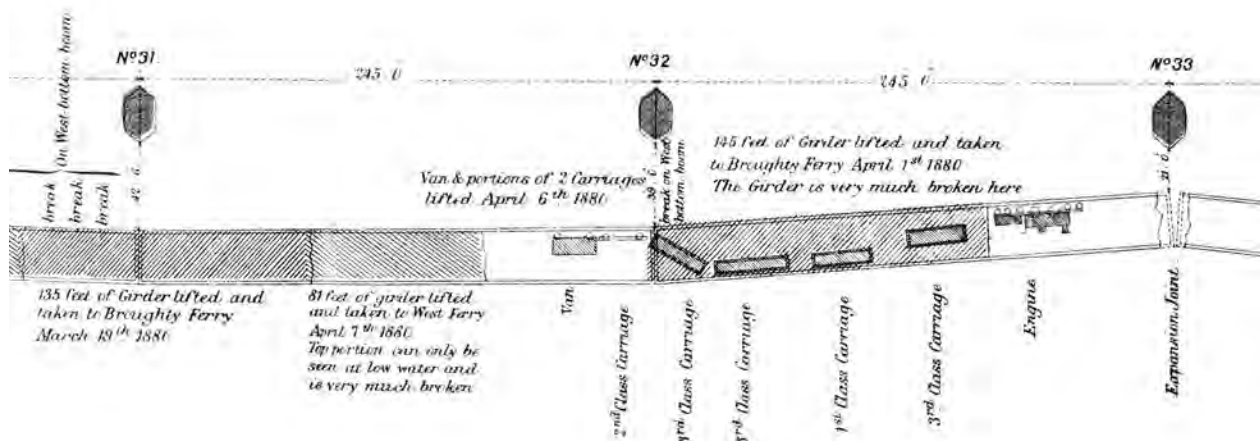
6 Plan of the section of the high girders between the fourth (no. 32) and fifth (no. 33) piers, showing the nearly intact train with the 4-4-0 locomotive at the front

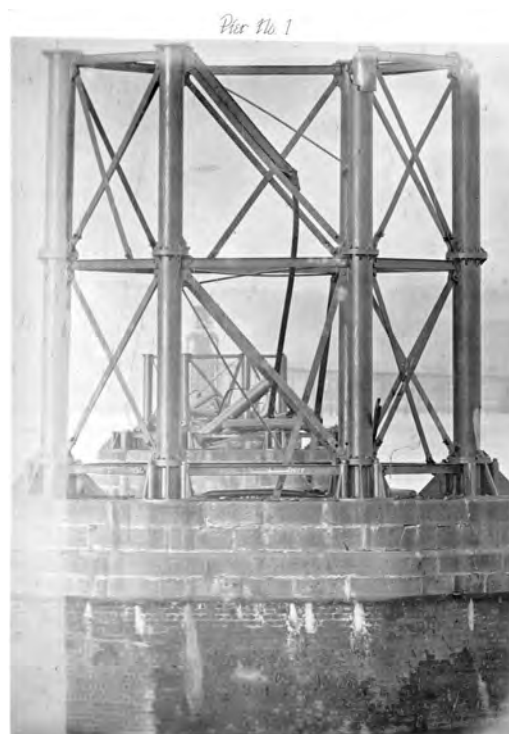
outside edges of the lugs holding bracing bars for each column (Fig. 9). There are nine such lug ends shown in Fig. 8, and while some may have come from adjacent broken tie bars (Fig. 10), the rest must have come from the missing higher tiers. Moreover, the two partly standing piers showed that the centre bracing bars facing east were most likely broken (Fig. 7). A similar pattern appears on the two fully

7 Two partly intact tiers on the first pier, photographed from the south looking north. East facing tie bars have all broken on the centre cells, while the west facing tie bars are intact. Breakage has occurred consistently at the lower lugs

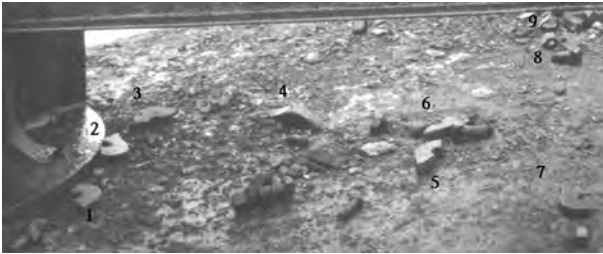
What we found most revealing was the nature of the debris on these two partly standing piers. Because most of the superstructure had been swept away, the stone platforms were relatively clear of debris, apart from fractured wrought iron bolts and broken pieces of cast iron of almost identical shape (Fig. 8). It turned out that these lumps of cast iron were the

8 Debris field with nine lug ends plus nuts and bolts on the platform of the third pier (looking east). Base of fifteen inch column at left showing structure of cotted joint

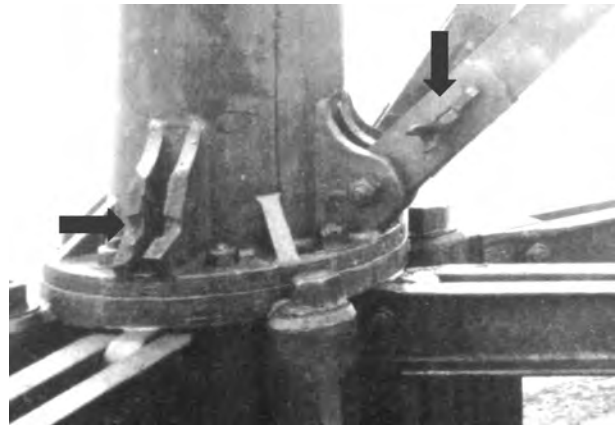
10 Broken lower lug on third pier (looking west), showing conical taper on bearing surface for one and an eighth inch bolt (lefthand arrow). The narrowest part of the hole is an inch and a quarter in diameter, so producing a large stress concentration at the contact zone. Joint at right shows gap between cotter and slot, allowing loosening with time (righthand arrow)

the taper section lugs, ill fitting bolts (Fig. 10), and the lack of a continuous connection at the head of the column where the high girder was supported by the pier. In effect, each tower consisted of two separate subtowers connected solely by the bracing bars and struts lying on an east–west axis (Fig. 2). That each subtower fell separately was suggested by the remains at the fifth pier, where the east tower lay under the high girder and the west on top. This observation was made by John Cochrane, an engineer called by Sir Thomas Bouch.

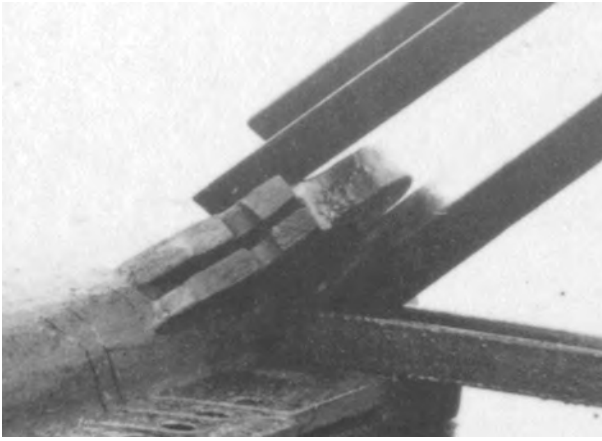
11 Conical taper on broken upper lug. The column shows part of a lifting wing used during construction of the bridge

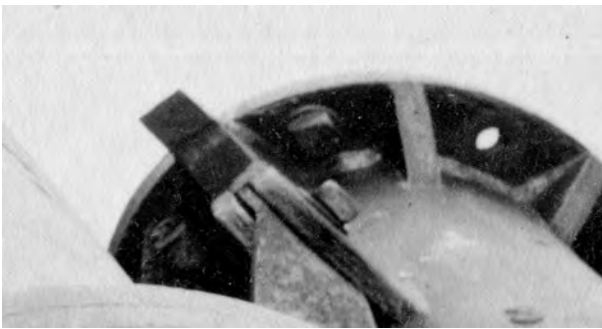
12 Conical taper on broken strut lug with intact upper lug joint in foreground

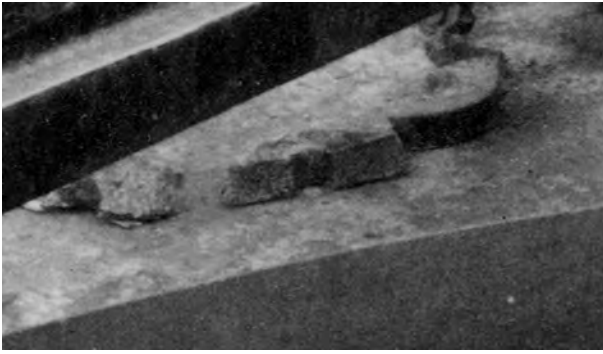
13 Closeup of three broken lugs from twelfth pier. The centre sample shows numerous crack arrest lines with a small blowhole on the lefthand wing of the lug, probably indicating intermittent crack growth (fatigue)

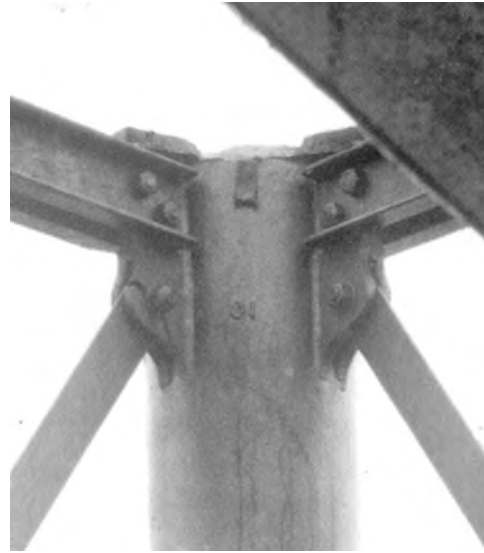
14 Closeup of fractured lug on third pier (looking west). Only one wing of the lefthand lug has broken, suggesting cyclic loading during or before the accident and collapse of the tower. There are no washers on the strut bolts, and these appear to be tightened by different amounts (judging by differing thread heights above the nuts)

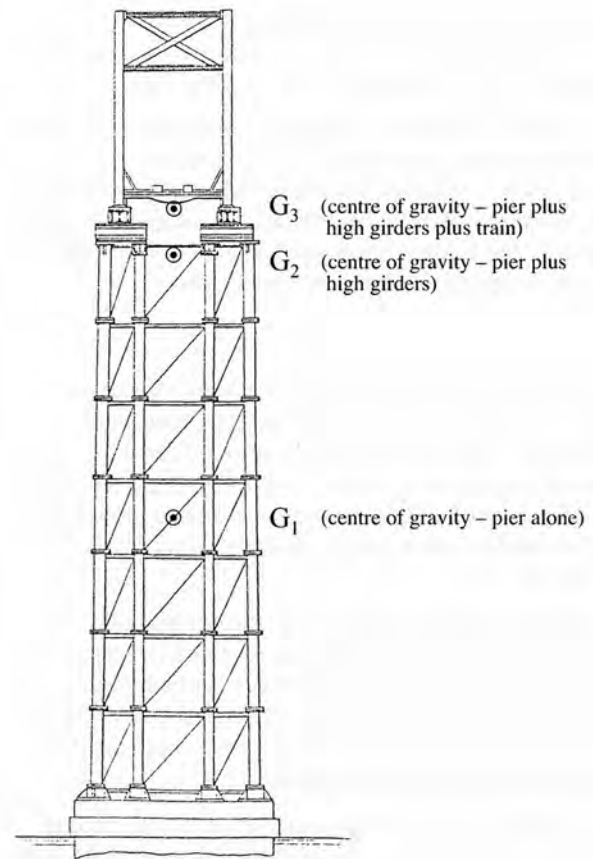
15 The towers in the high girders section of the bridge were top heavy, the centre of gravity lying near the level of the track when the express train from Edinburgh crossed on the night of 28 December 1879

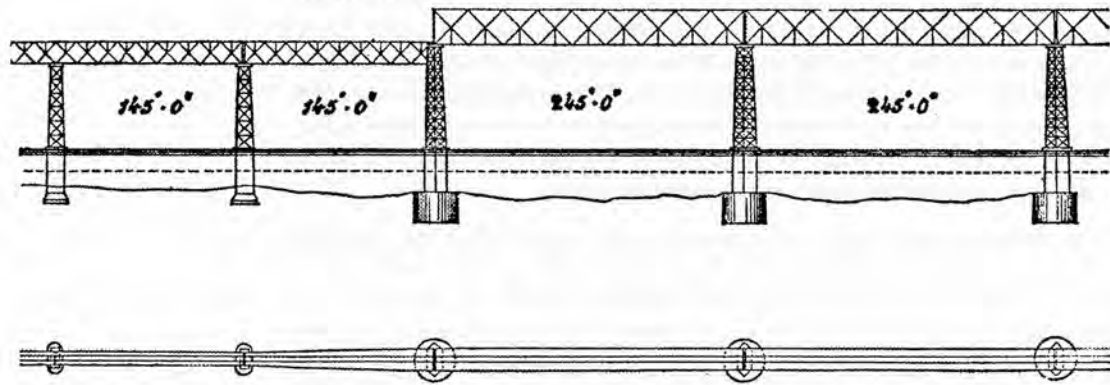
TAY BRIDGE, ARRANGEMENT OF PIERS & GIRDERS.

- 16 The centres of gravity of the towers in the lower part of the bridge were much lower because the piers were closer together and supported smaller girders of lower weight, which helps to explain why they survived the collapse
