Forensic engineering: a reappraisal of the Tay Bridge disaster

PETER R. LEWIS and KEN REYNOLDS

Department of Materials Engineering, Open University, Milton Keynes, UK

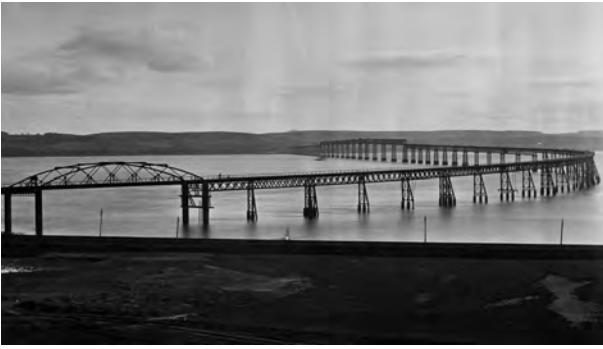
1 The Tay Bridge just after completion, showing the centre or 'high girders' section needed to allow passage of high masted sailing ships upstream along the river to Perth (clearance was about eighty-eight feet at high tide). Some finishing work was still being performed on the bridge, judging by the staging and ladders seen at various points

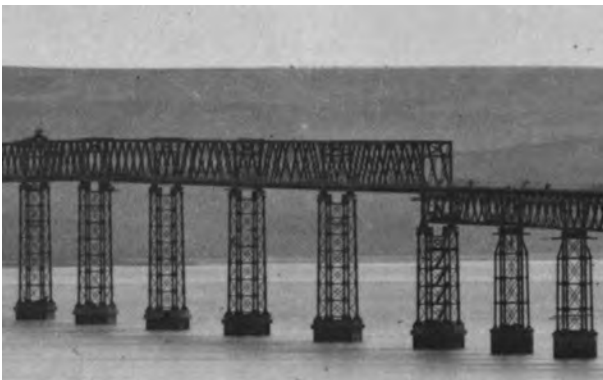
2 Closeup of the join between the high girders at left and the low girders at right on the Dundee side of the bridge. The centre of each high tower shows the diagonal tie bars and horizontal struts which united the two sub-towers. Unlike the low towers at extreme right, the tops of the high towers are not reinforced by complete girders

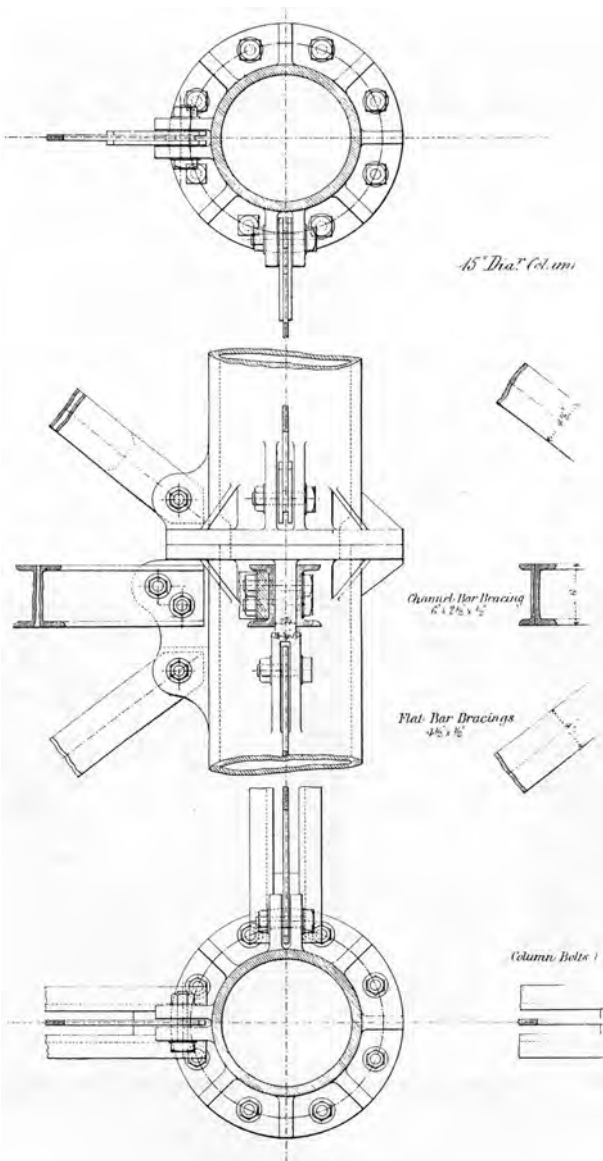
outside edges of the lugs holding bracing bars for each column (Fig. 9). There are nine such lug ends shown in Fig. 8, and while some may have come from adjacent broken tie bars (Fig. 10), the rest must have come from the missing higher tiers. Moreover, the two partly standing piers showed that the centre bracing bars facing east were most likely broken (Fig. 7). A similar pattern appears on the two fully

9 Line drawing of various joints on fifteen inch diameter column, including upper and lower lugs, strut, and flange, all cast as one with the column (Institution of Civil Engineers)
